Manhole Inspection Summary

Manhole # S25I__060MH

Insp Date: **4/1/09 10:14 AM**

Location Address: **Holton Alley**

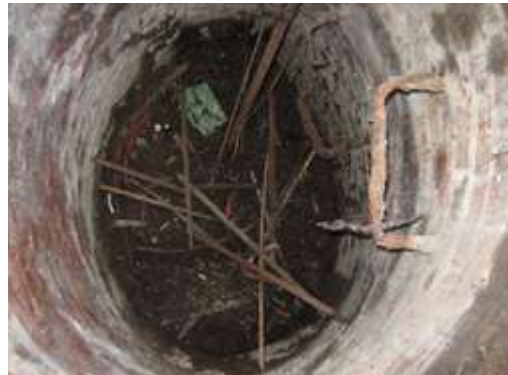
Top View

heavy sediment and debris in mh.

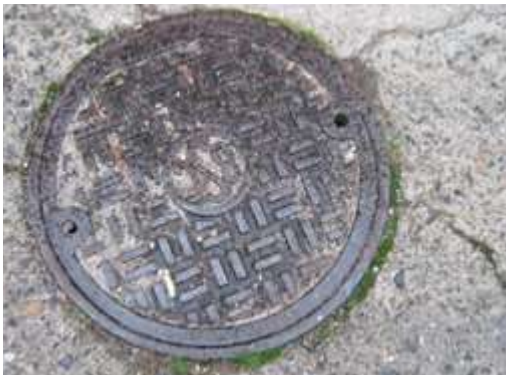
Defect 6

mh cover

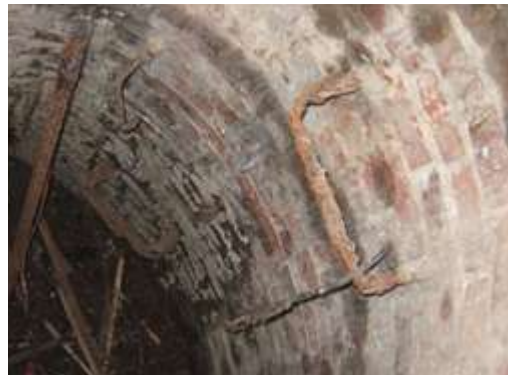
Defect 8

Steps Count: **4** Missing: **2** ☒ **Corroded**

corroded and missing rungs

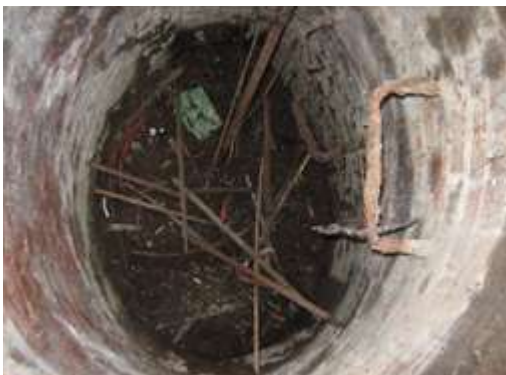
Defect 5

Condition: ☐ Sound ☐ Cracked ☐ Root Intrusion ☐ Deteriorated ☐ Leaks ☒ **Debris**

heavy sediment and debris in mh.

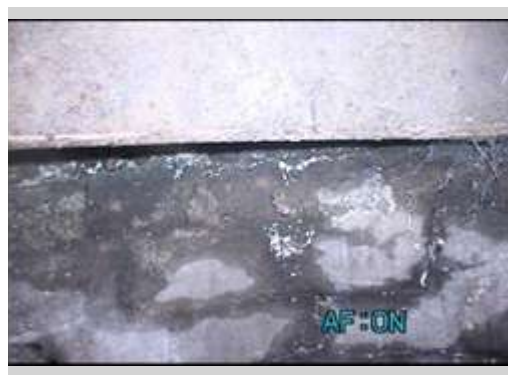
Defect 1

Frame Offset: **2** (in.) Condition: ☐ Sound ☐ Cracked ☒ **Leaks**

Infiltration: ☐ None ☐ Joint ☐ Cracks ☒ **Mortar** ☐ Roots ☐ Wall

active infiltration at frame and chimney joint

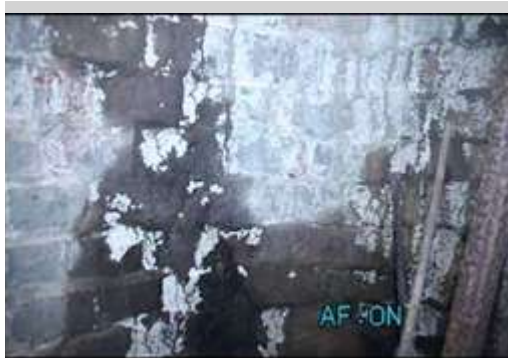
Defect 7

Infiltration: ☐ None ☐ Joint ☐ Cracks ☐ Mortar ☐ Roots ☒ **Wall**

infiltration on corbel wall

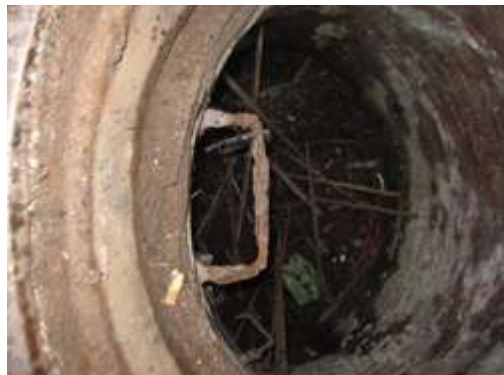
frame offset 2"
